U.S. Army Toxic and Hazardous Materials Agency
**Report of Sampling and
Analysis Results**

Midway Army Housing Units
Kent, Washington

August 1990

**SAMPLING AND ANALYSIS AT THE U.S. ARMY
FAMILY HOUSING UNIT (FHU) PROPERTY
KENT, WASHINGTON**

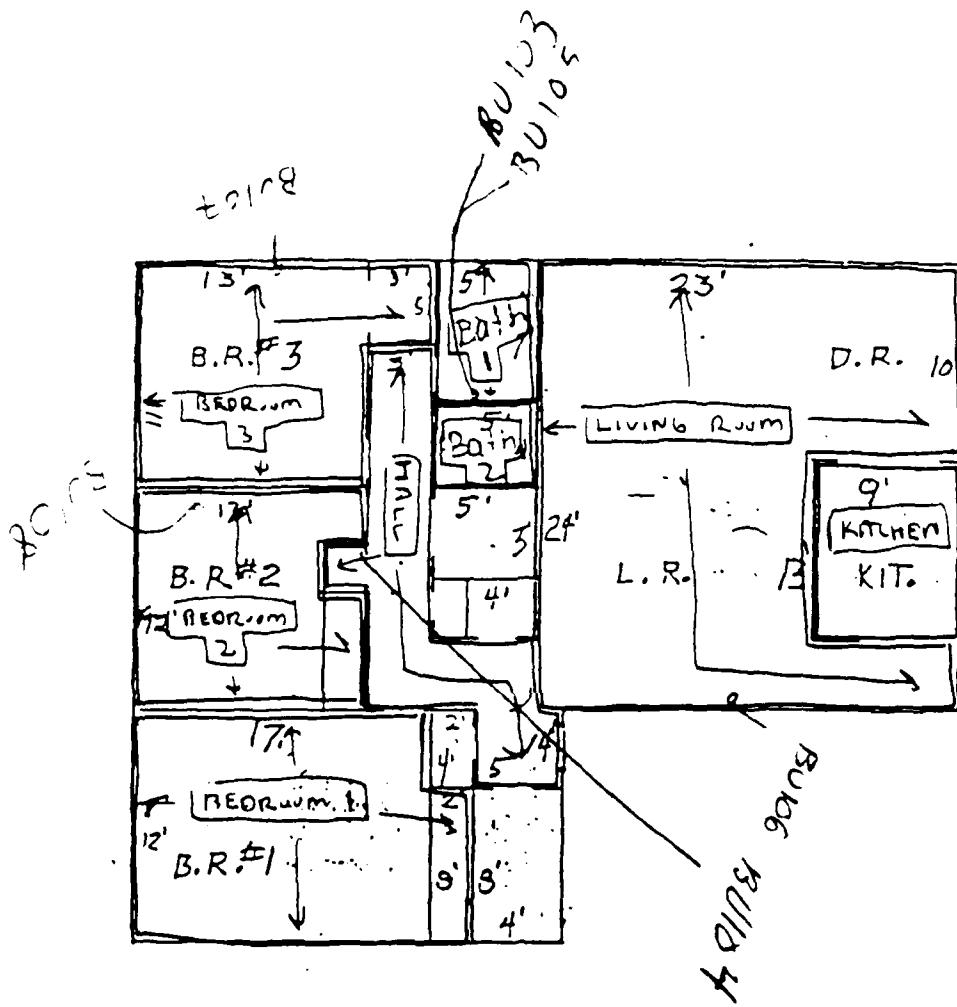
M-06

Building is a three bedroom, Cup-hat-style house with vinyl siding and plasterboard walls inside. There is a granular, spray-on paint on inside walls and ceiling. Structure is one story, wood framed, with a concrete foundation, and tar and gravel roof.

Expansion joint and furnace gasket found on heater unit.

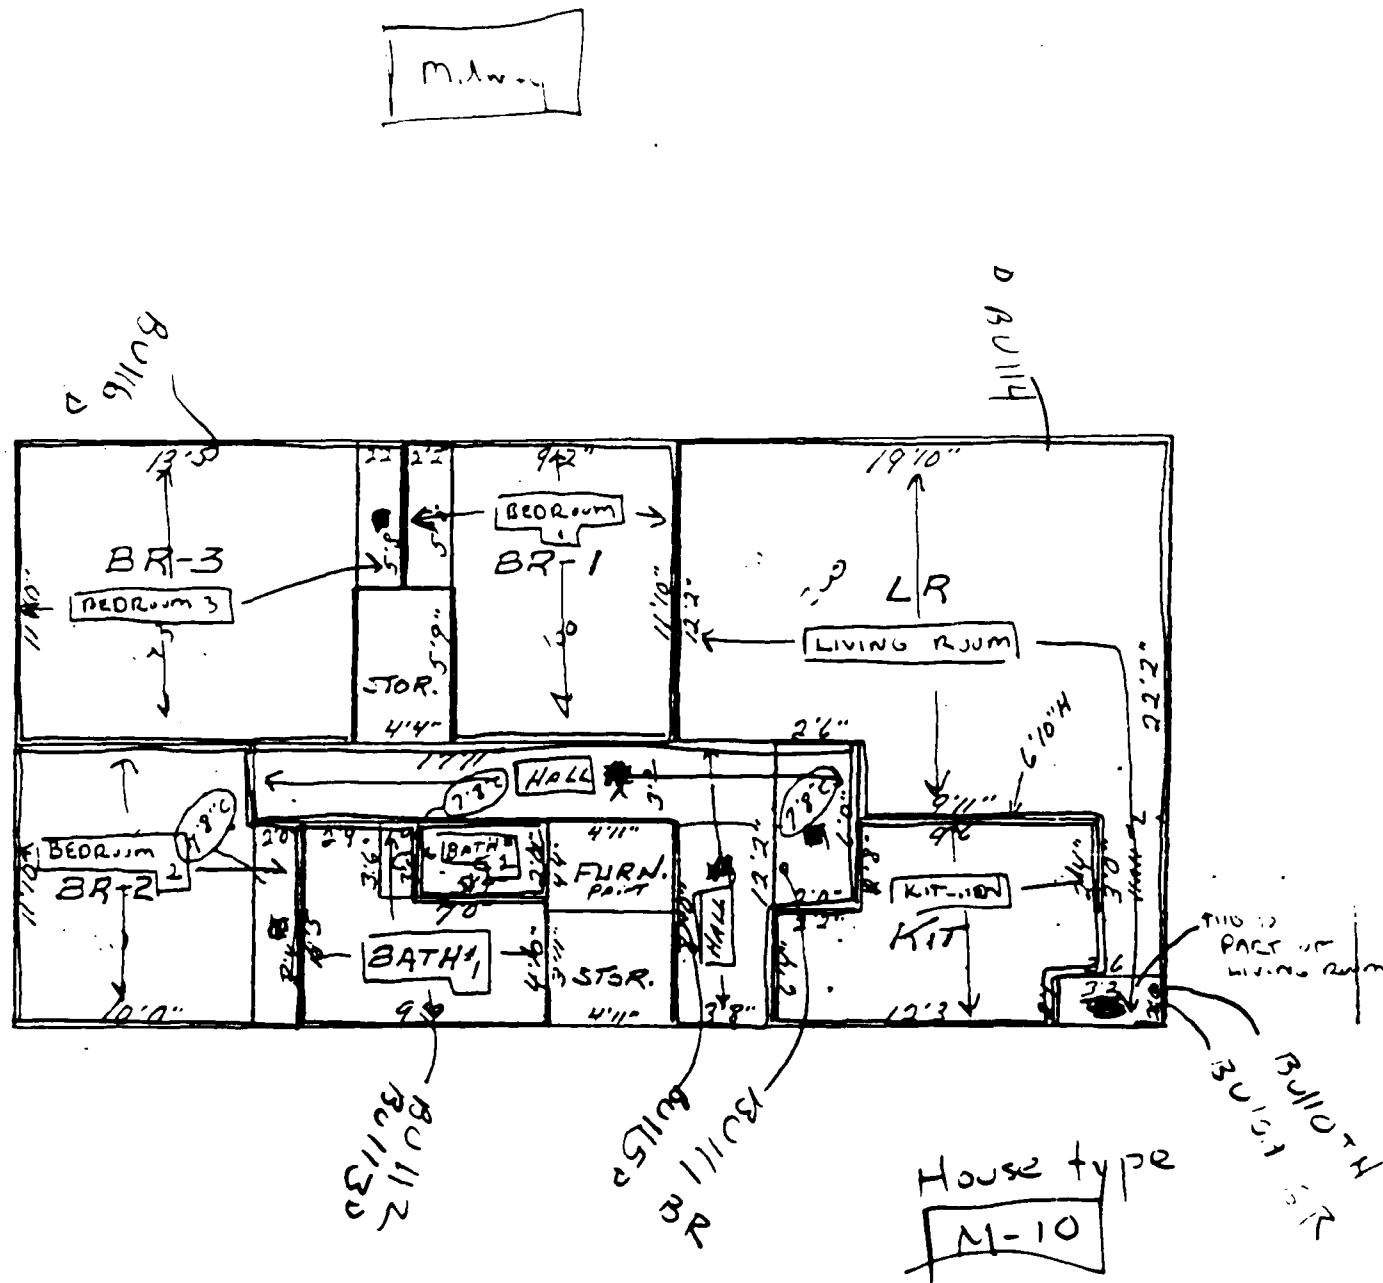
M-10

Building is a three bedroom, bungalow-style house with vinyl flueing and plaster board walls inside. There is a granular, spray-on finish on inside walls and ceiling. Structure is one story, wood framed, with a concrete foundation, and tar and gravel roof.

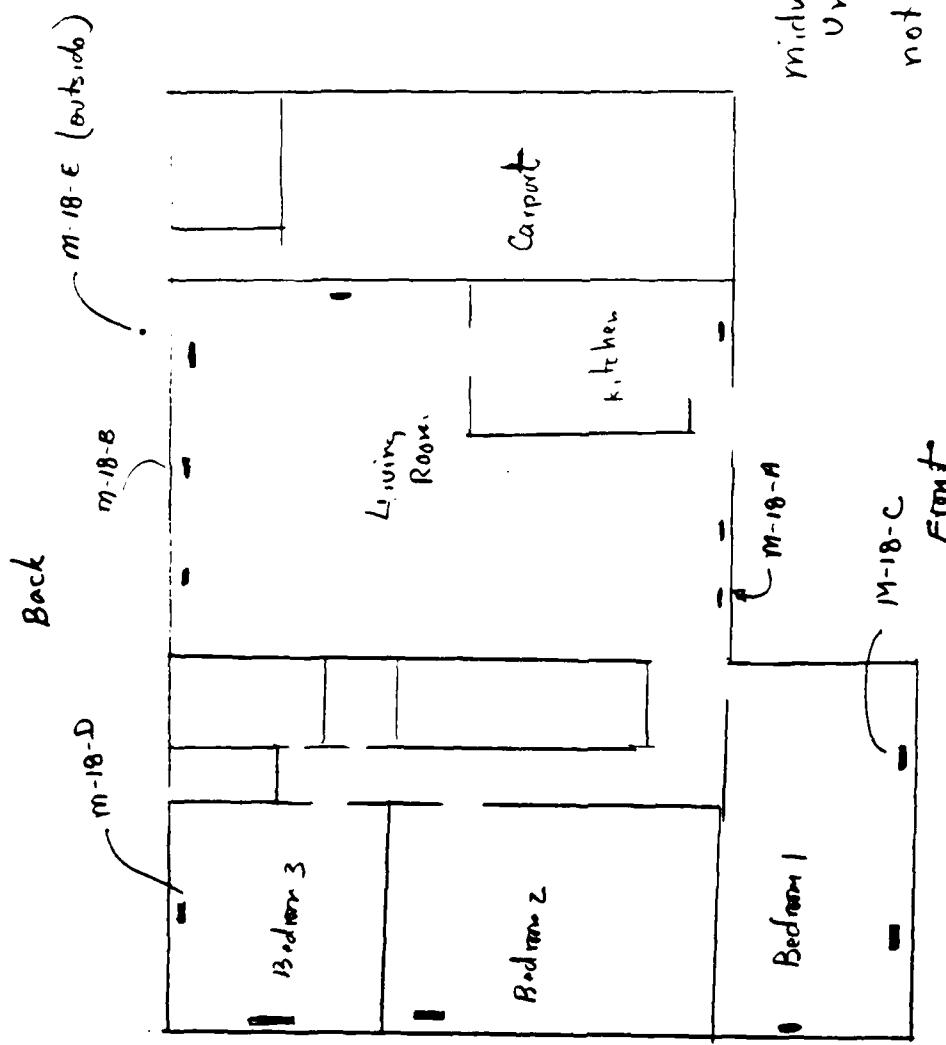
Midway Housing
Unit m-18
4/12/90
not to scale

- represents registers in floor
